Fenomén „GLOF“ jako projev změny klimatu

Jan Kocum, Bohumír Janský et al.

Vybrané kapitoly z fyzické geografie

Liberec 2024

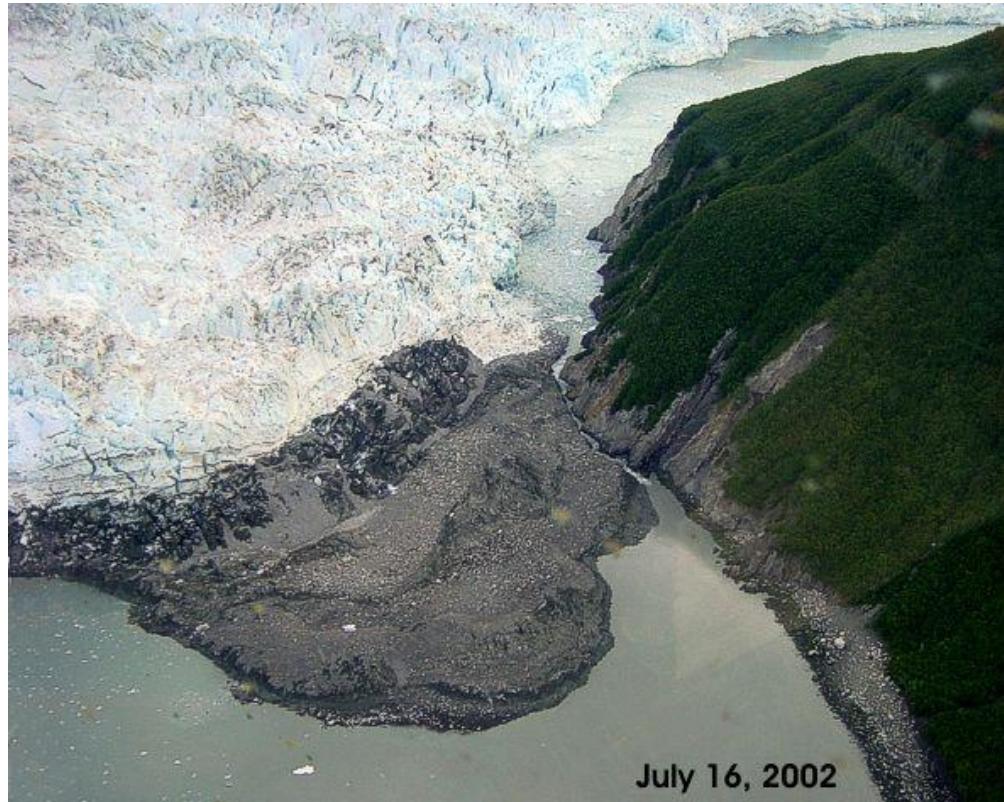
In this Hubbard Glacier image from 16 July 2002, the glacier has closed off Russell Fjord from Disenchantment Bay. The waters behind the glacier rose 61 feet (19 m) in 10 weeks, creating a short lived Russell Lake.

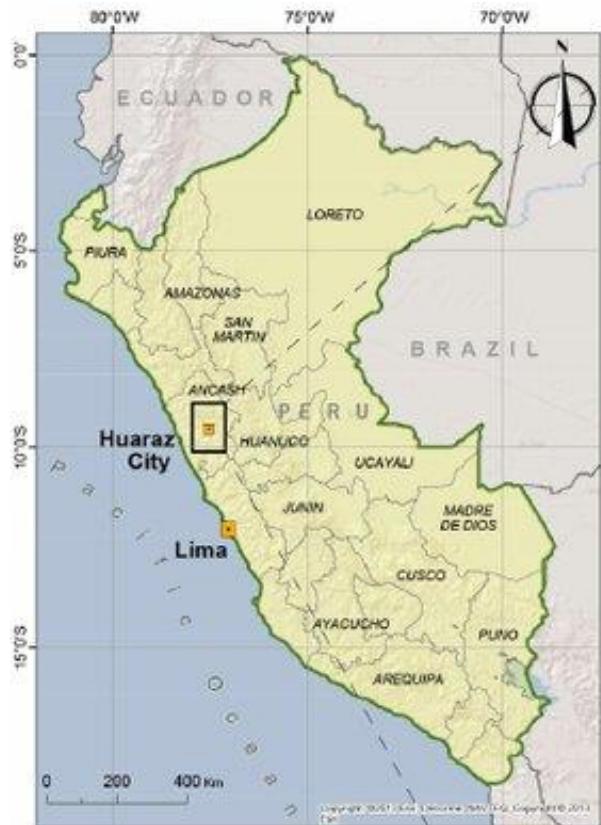
Lake Palcacocha
location, upstream
from Huaraz city in
the Cordillera
Blanca in Peru

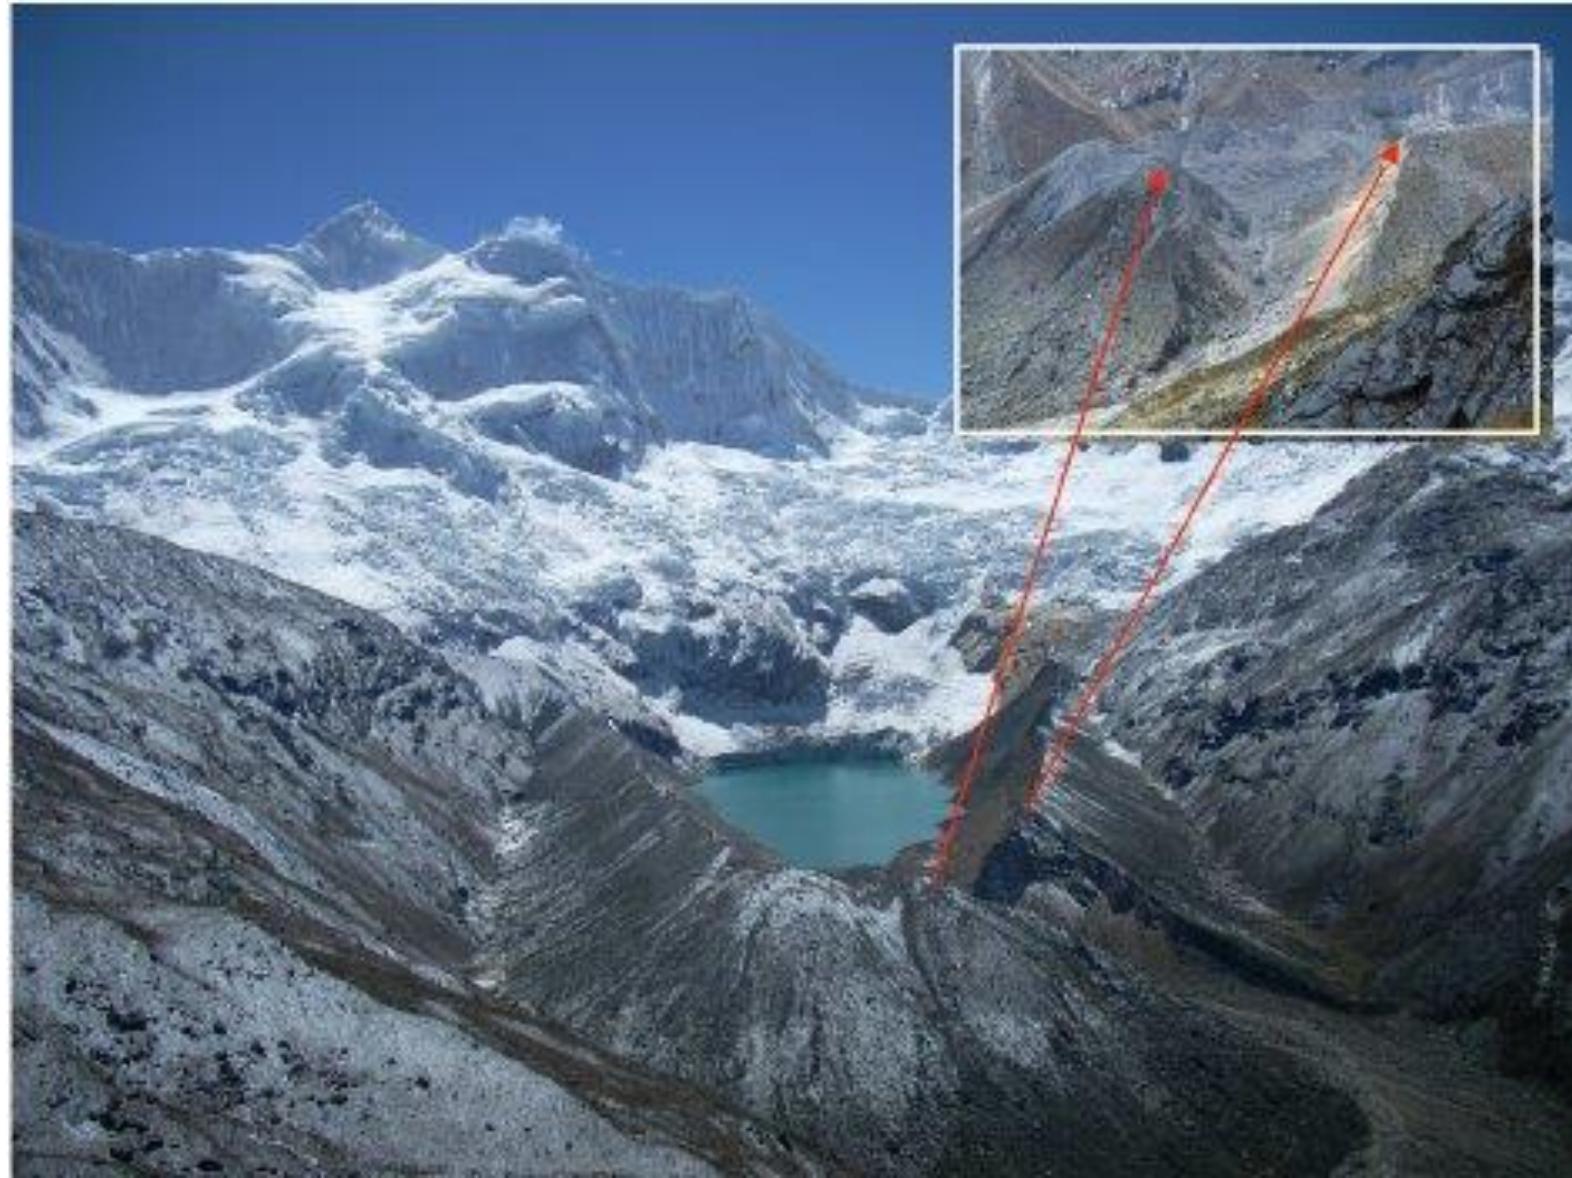
Front views of Lake Palcacocha and the breach of the 1941 GLOF

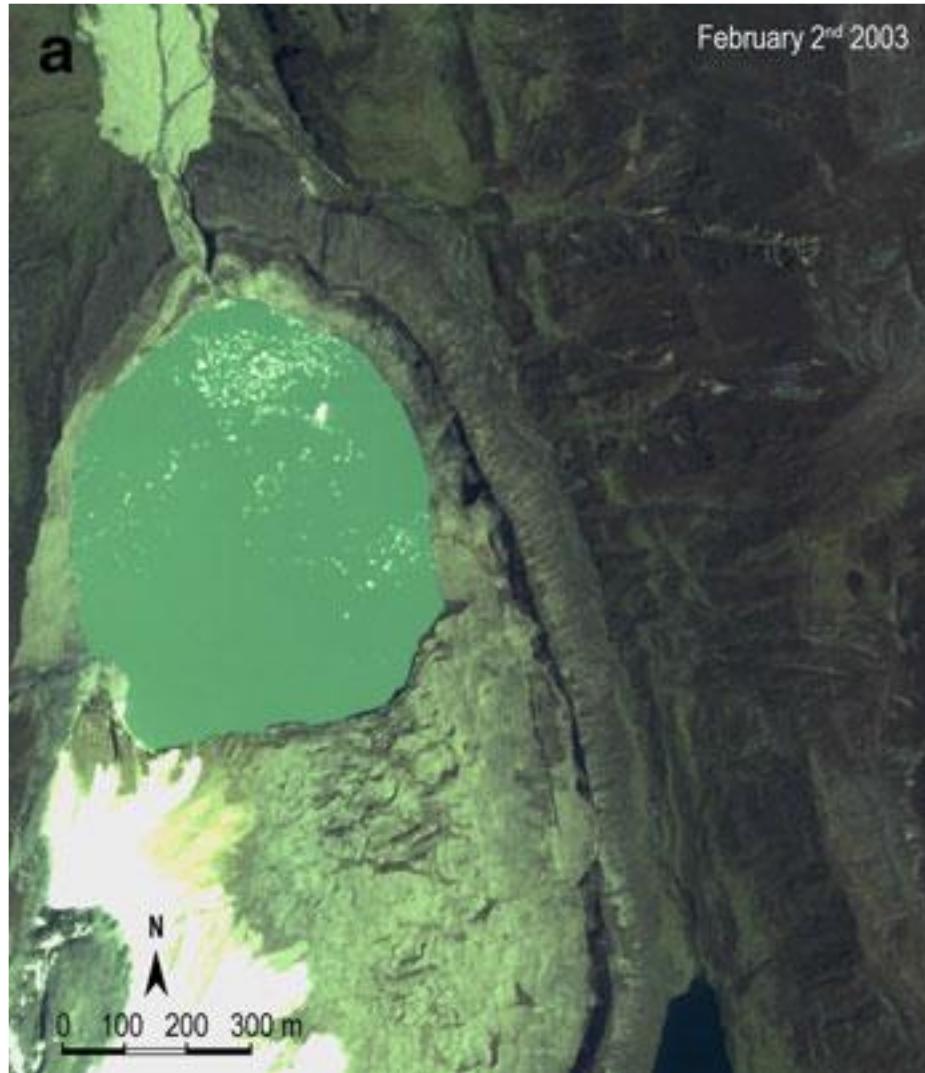
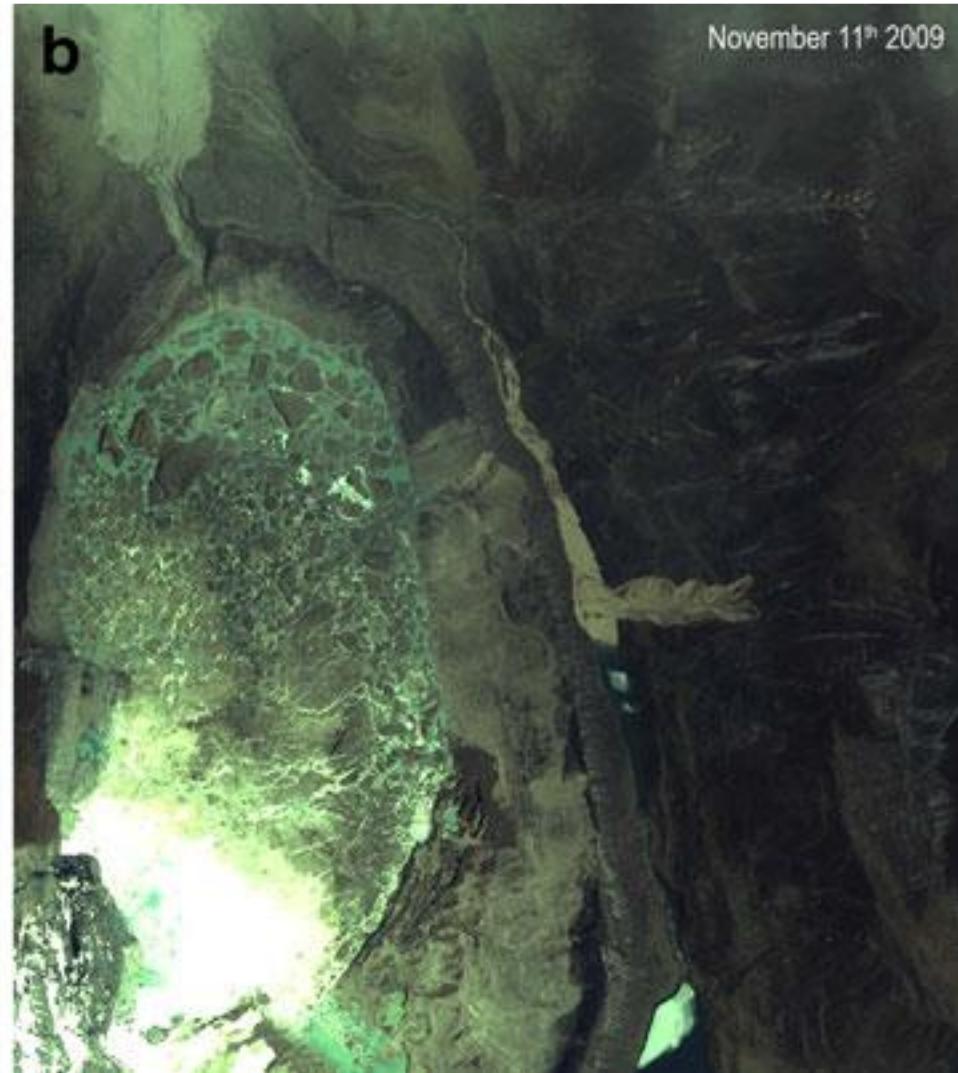
QuickBird images of the study area.

a: Pre-failure (2003), b: Postfailure (2009).

The relief and hydrographic changes in the valley of Carhuacocha River after debris flows from 8.3.2009

The debris flow was triggered by cumulative rainfall combined with an extreme precipitation event:

- From the end of January to the beginning of March 2009, the Cordillera Huayhuash experienced abnormally high precipitations exceeding **270 mm**.
- The annual precipitation at the nearby Cajatambo station (distance 25 km) is **563 mm**.
- 10 days prior to flow – 56,2 mm
- 24 h prior to flow – 18,4 mm

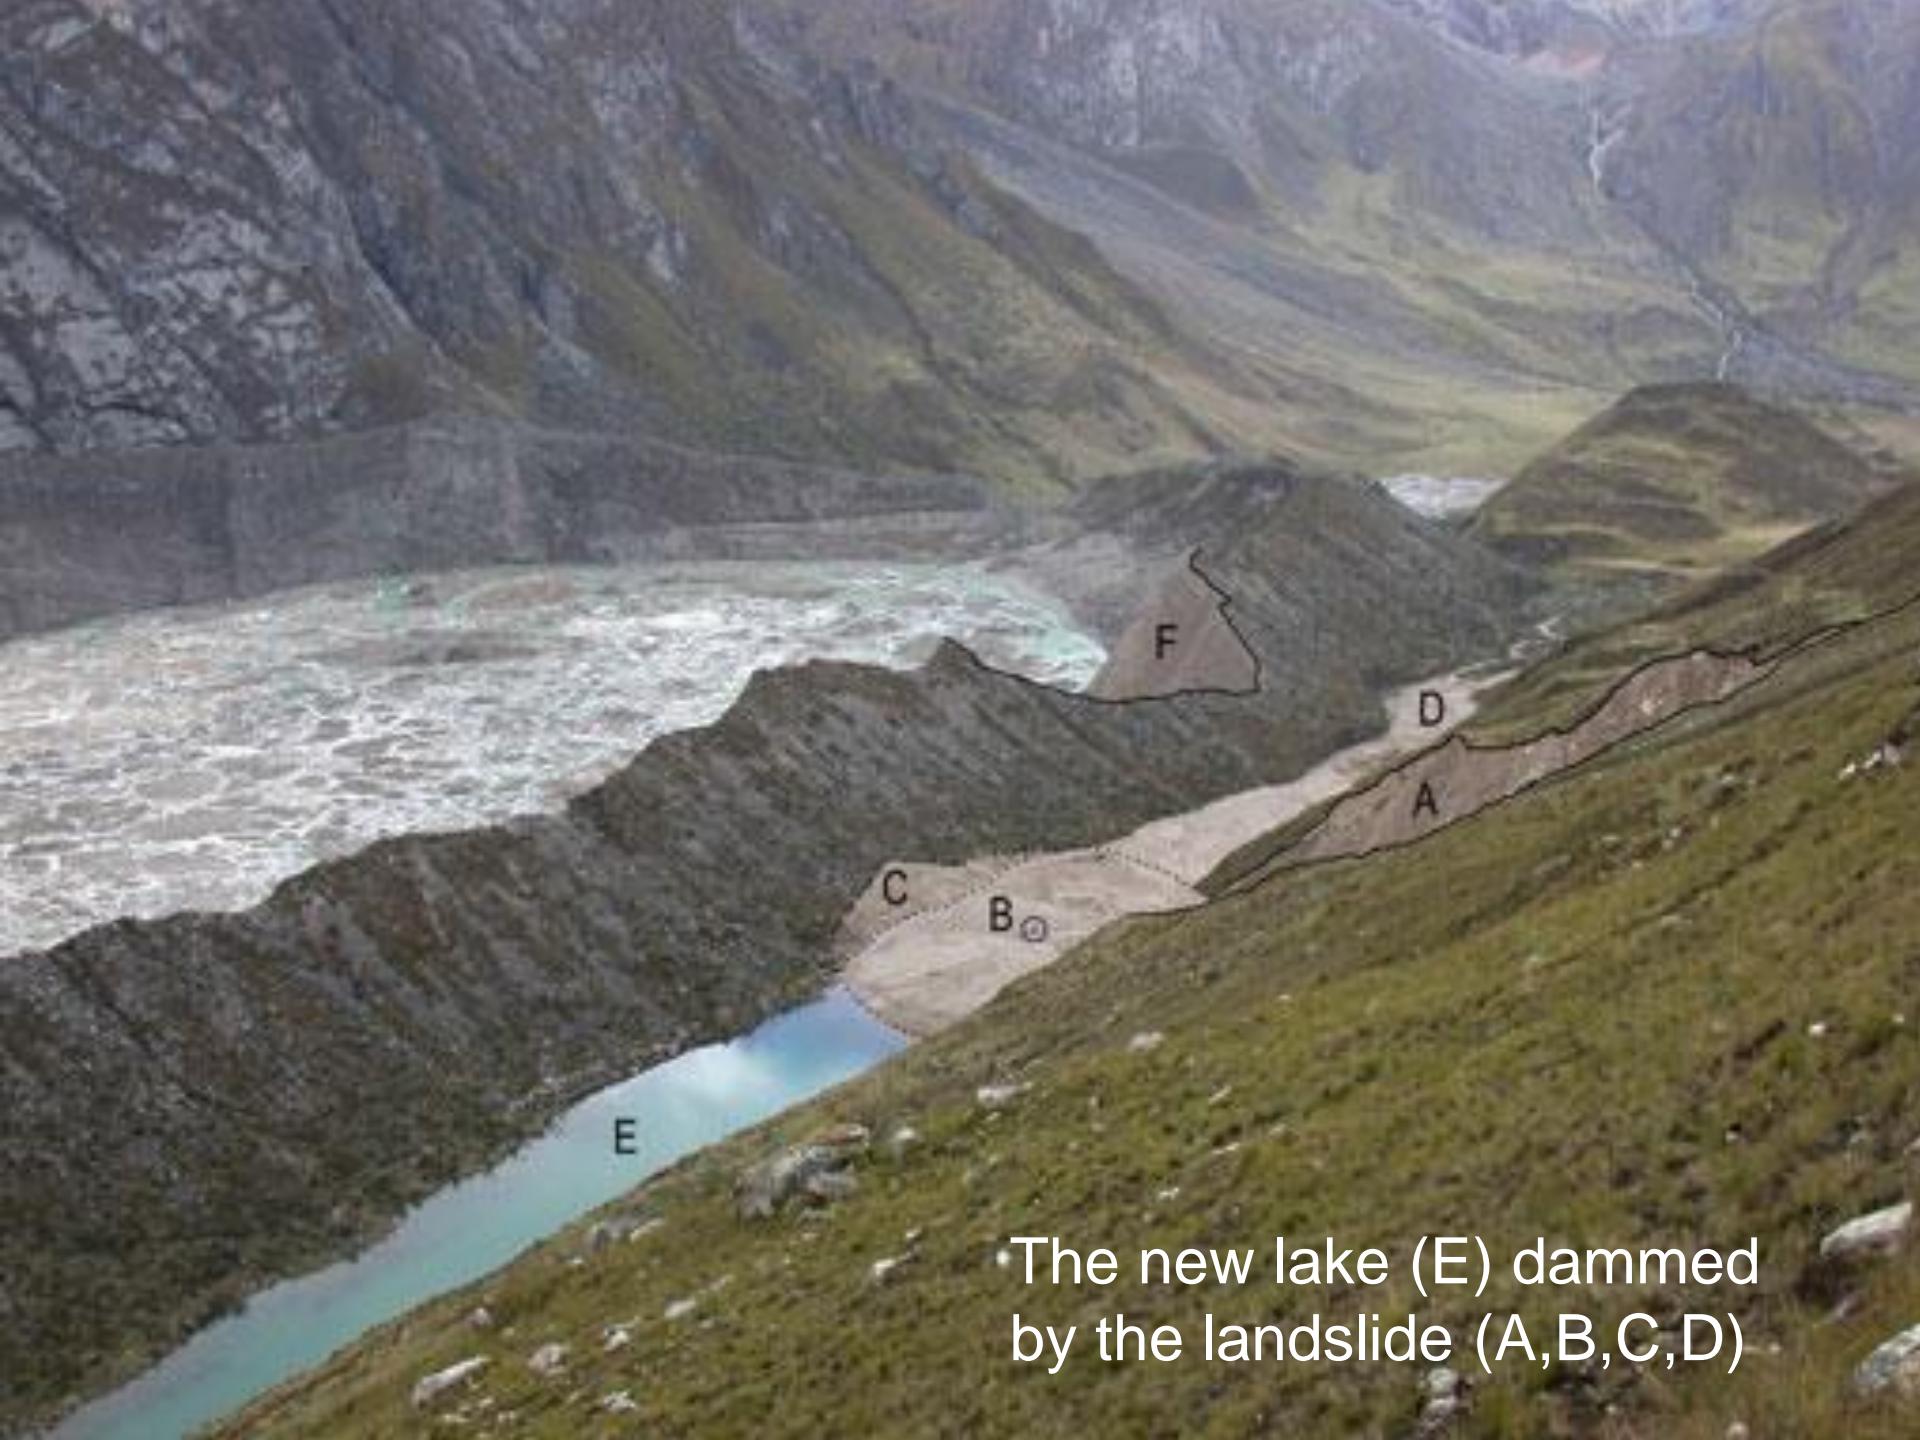
The new lake (E) dammed
by the landslide (A,B,C,D)

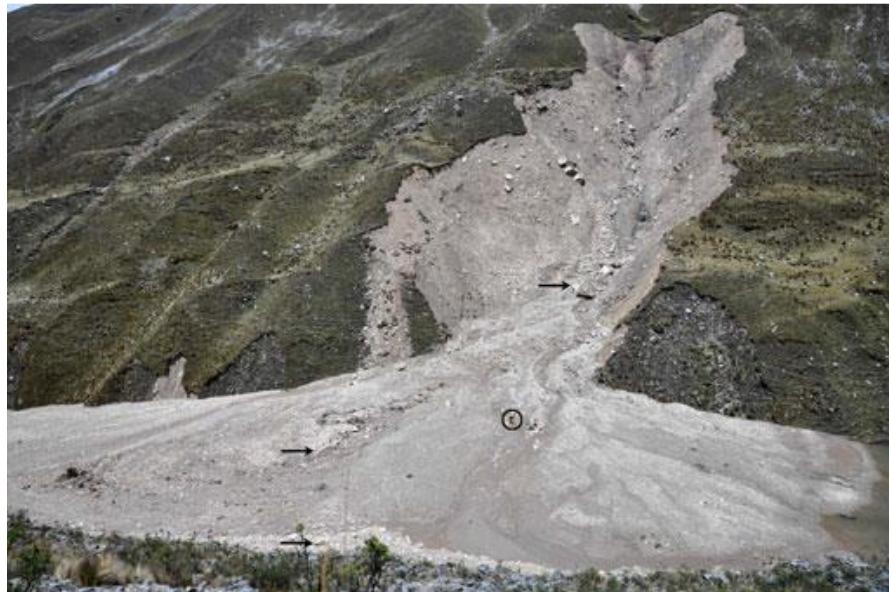
New hydrographic situation after landslide:

- water percolated through the moraine dam of Cangrajanca Lake
- lateral moraine disturbed by groundwater erosion

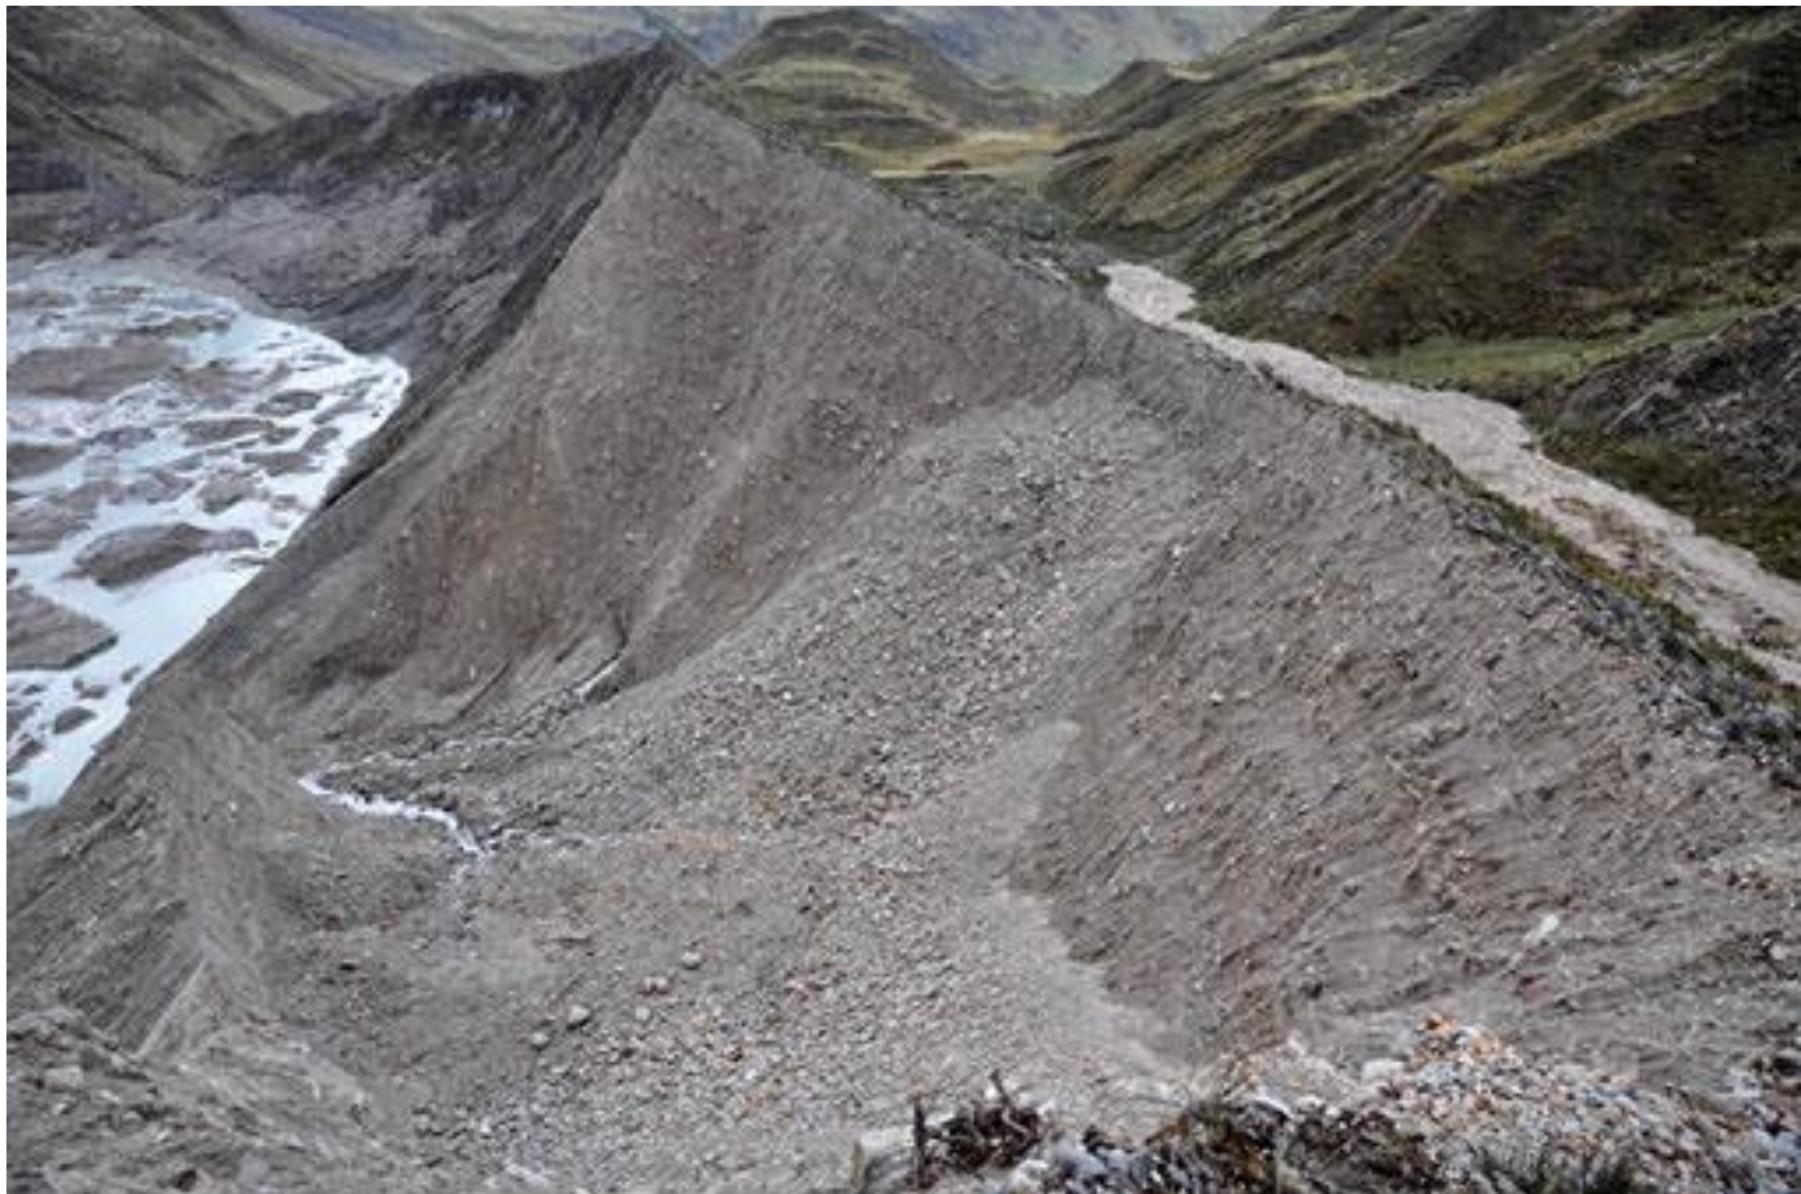
Lateral moraine: disturbed by groundwater erosion
